NAV340 & NAV350 - Firmware release information 1.x.x

Update Instructions

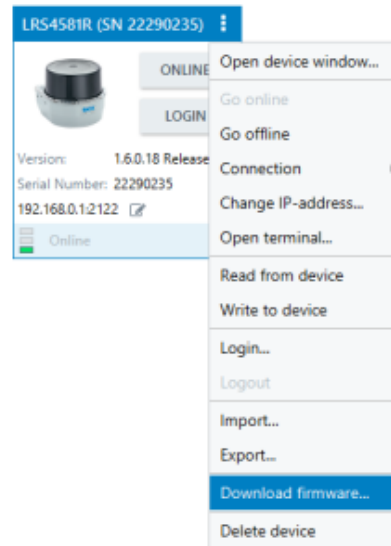
6 Open the settings and choose **Download firmware**.

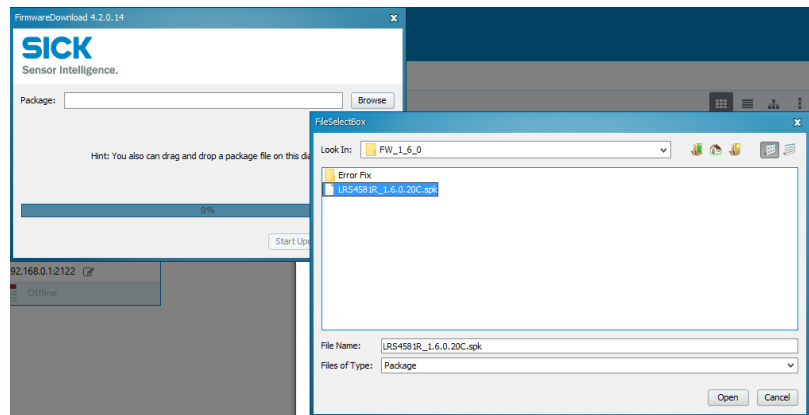
7 Select the firmware package (.spk) and start the update process.

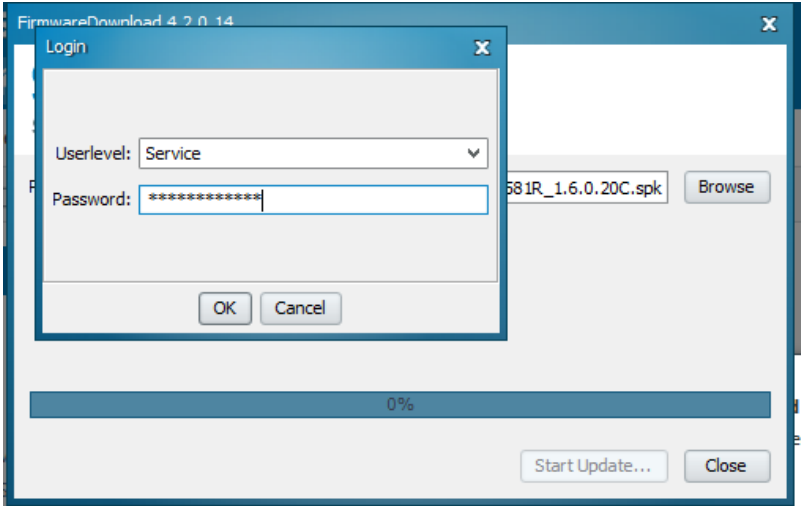
8	<p>Log-in to the LiDAR with user level: Service and password: servicelevel</p> <p>The update procedure may take up to 2 minutes.</p>

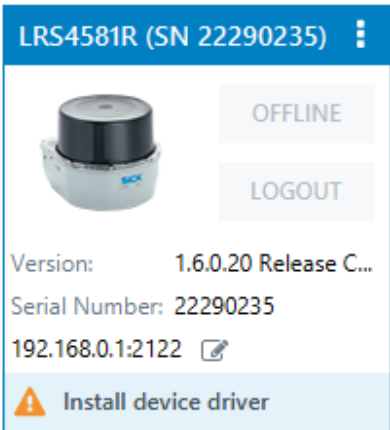
9	<p>Wait until the reboot is completed and the device LED turns green.</p>	
10	<p>Check the SOPAS window for the correct firmware version.</p> <p>Depending on the firmware update, the SOPAS ET device driver may need to be reinstalled by pressing "install device driver".</p>
