picoScan150 - Firmware release information V1.x.x

Document published 23 Aug 2024

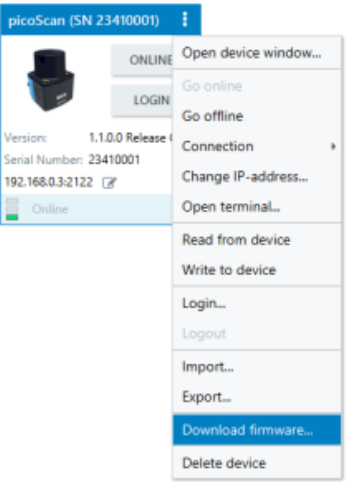
5	Open the settings and choose Download firmware.

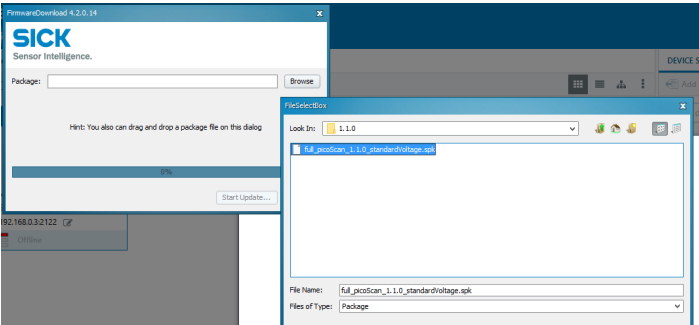
6	Select the firmware package (.spk) and start the update process.

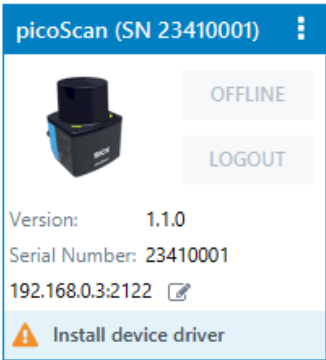
8	Wait until the reboot is completed and the device LED turns green.	
9	Check the SOPAS window for the correct firmware version. Depending on the firmware update, the SOPAS ET device driver may need to be reinstalled by pressing "install device driver".

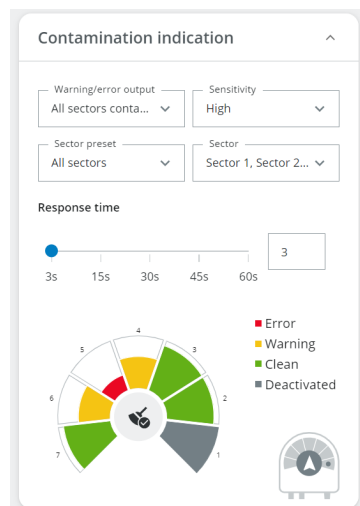
Contamination indication

The contamination indication evaluates 7 sectors regarding their contamination levels. The result can be monitored in the GUI, via digital outputs or via telegram. The response time can be adjusted.

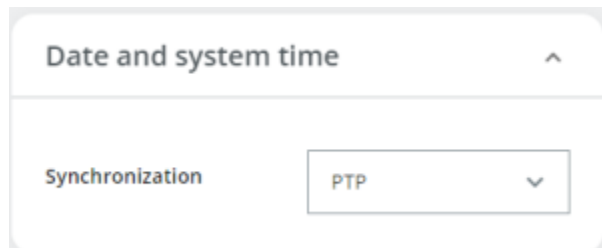
Precision Time Protocol (PTP) support

PTP is a synchronization mechanism ensuring precise coordination of data acquisition across multiple LiDAR units or other clients within a network. By synchronizing the internal clocks of devices, PTP enables accurate time-stamping of measurements, crucial for precise spatial mapping and object detection. This synchronization minimizes latency and ensures reliable data fusion in applications like autonomous vehicles or industrial automation.

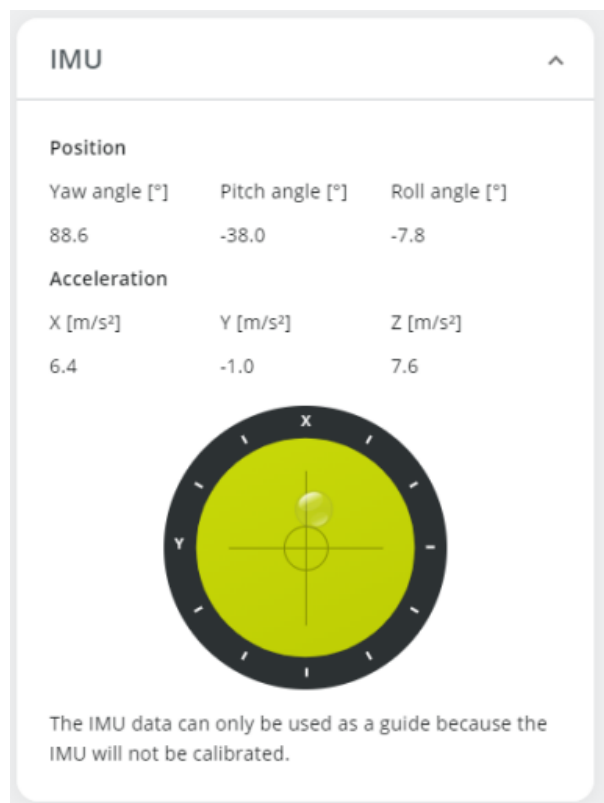
IMU (inertial measurement unit support)

IMU data is enabled with this release. IMU data is available in compact format. The following info is shown in the UI.

IMU type: BOSCH BHI160B
